5.0 Operable Unit 3, the Old City Dump

5.2 Remedial Investigation Activities at Operable Unit 3, the Old City Dump

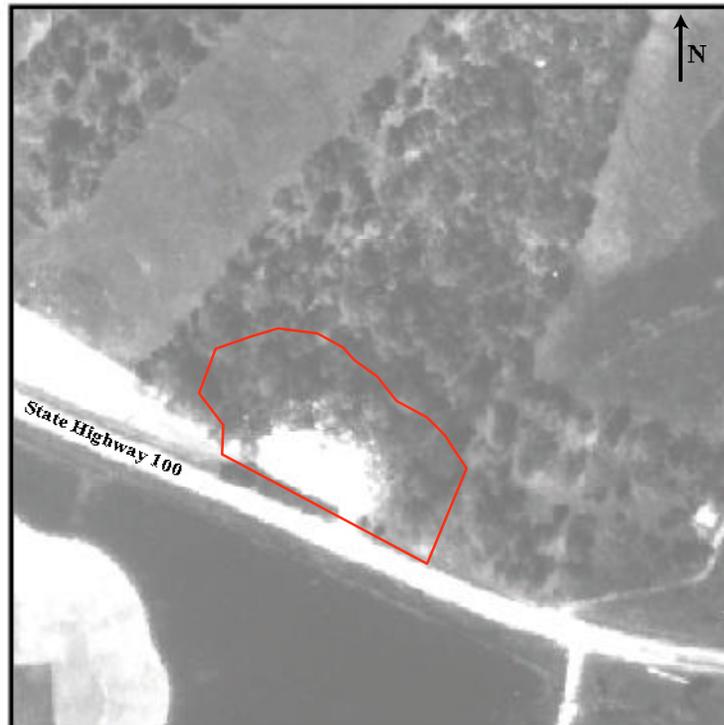
Figure 5-3. Aerial photographs of Operable Unit 3 (OU3) during 1945 and 1958.

this period it appears that wastes were being dumped mostly on the north face and that the fill area slowly expanded outward from the original fill area (figs. 5-3, 5-4). During 1976 and 1979, some sort of solid wastes (possibly demolition or yard waste) appeared to be stockpiled in the northern part of the dump (fig. 5-5). These wastes may have been dumped in piles of similar size (as if from a dump truck) at regularly spaced intervals (fig. 5-5). Access to the dump from the gravel road to the west was closed by 1976. By 1979, the southern one-half of the dump appeared to be covered with grass and piles of solid waste in rows covered the northern part. During 1984, the south and east part of the dump appeared to be disturbed and the northwest part was covered with grass (fig. 5-6). During 1984 excavation had begun on the industrial building east of OU3, along what would become East Industrial Drive, and by 1986 the industrial building was occupied (fig. 5-6). The surface of the dump was mostly covered with grass and little activity appeared to be occurring in 1986.

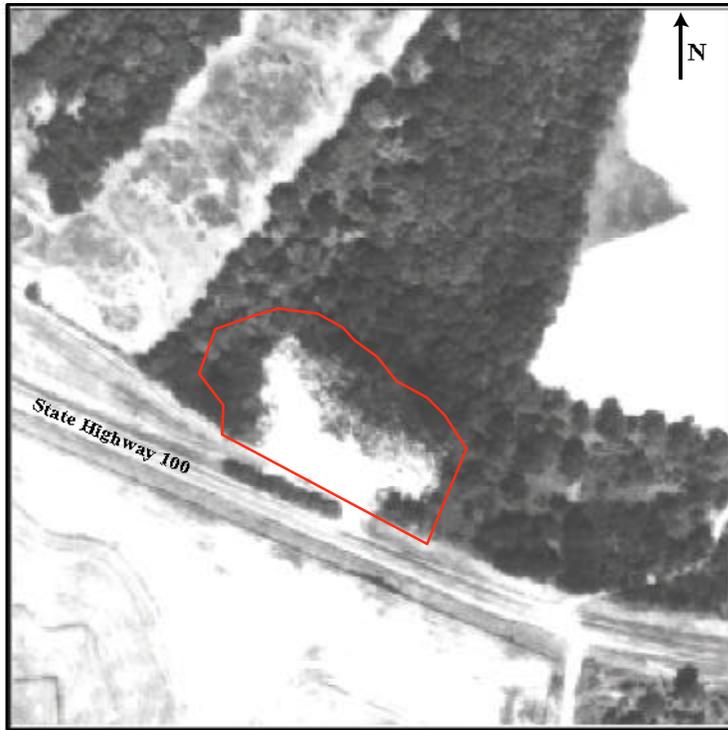
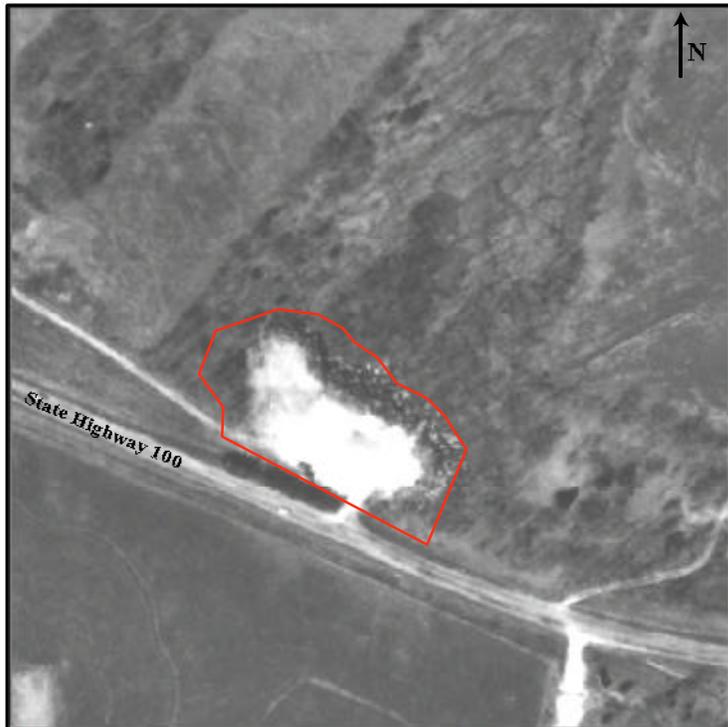
Figure 5-4. Aerial photographs of Operable Unit 3 (OU3) during 1965 and 1970.

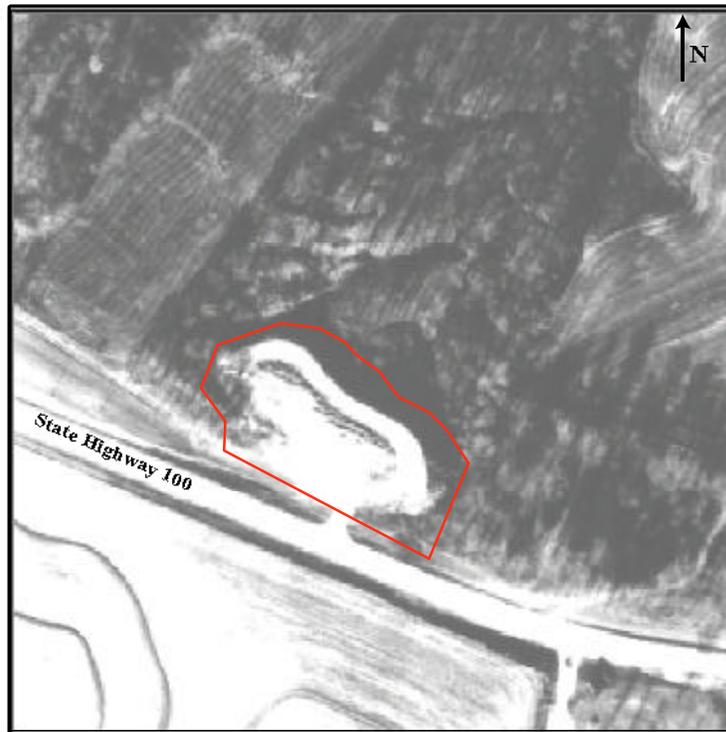
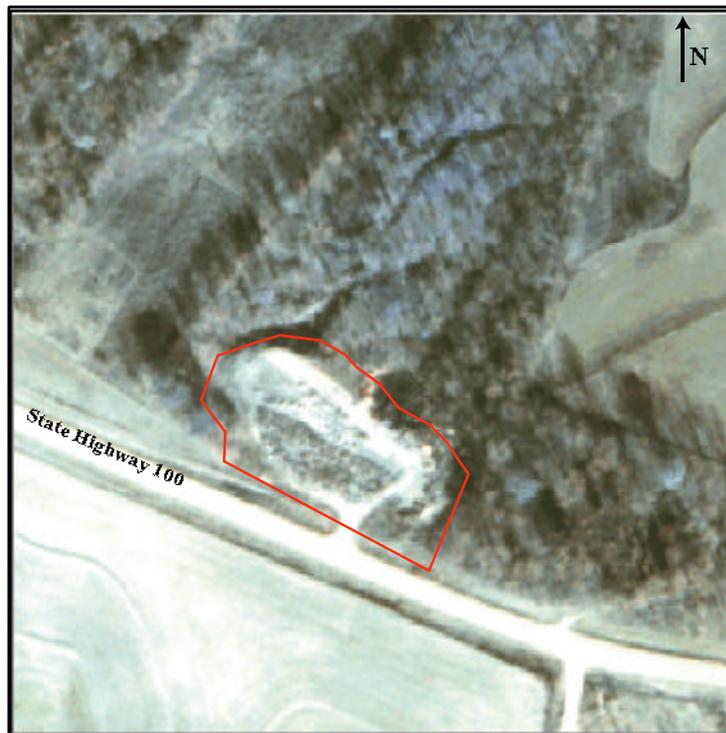
Figure 5-5. Aerial photographs of Operable Unit 3 (OU3) during 1976 and 1979.

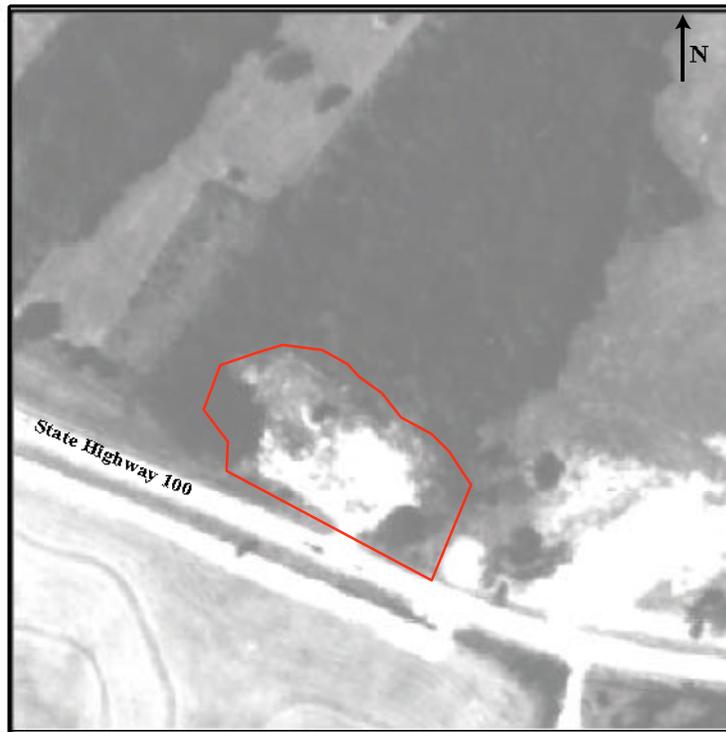
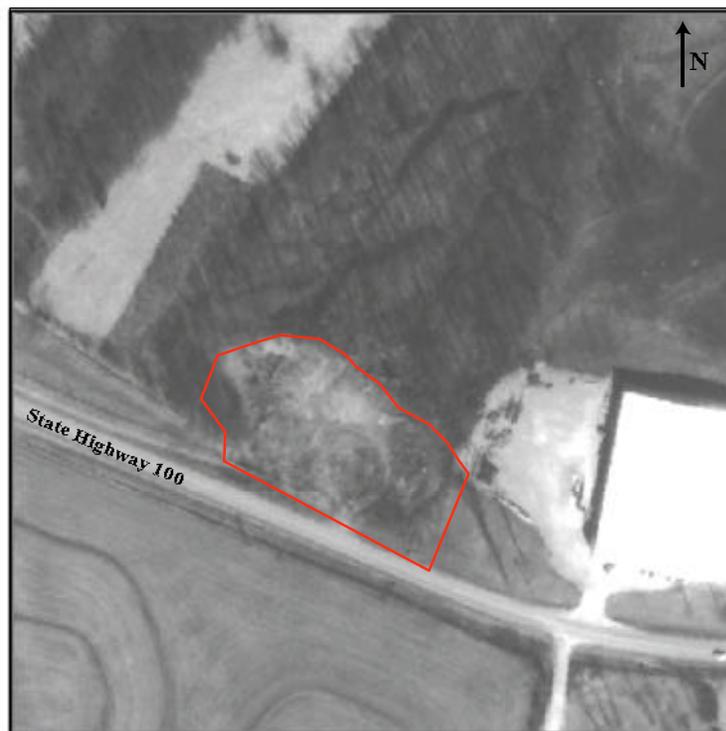
Figure 5-6. Aerial photographs of Operable Unit 3 (OU3) during 1984 and 1986.
